# VARIABILITY OF MODAL PARAMETERS MEASURED ON THE ALAMOSA CANYON BRIDGE

Charles R. Farrar<sup>1</sup>, Scott W. Doebling<sup>1</sup>, Phillip J. Cornwell<sup>3</sup>, Erik G. Straser<sup>3</sup>

<sup>1</sup>Engineering Analysis Group (ESA-EA)  
MS P946  
Los Alamos National Laboratory  
Los Alamos, NM 87545

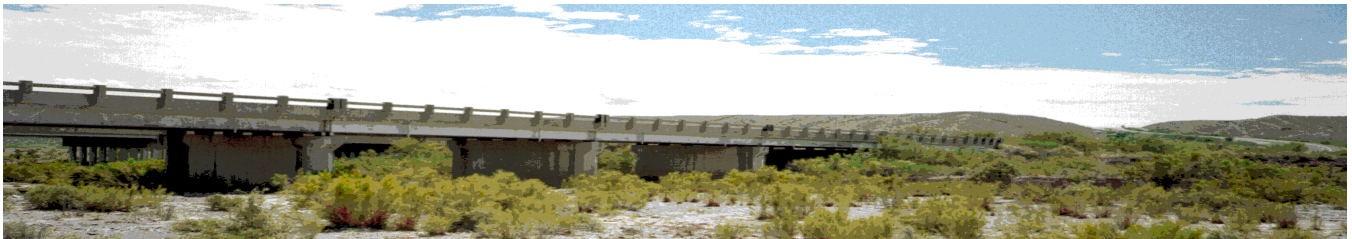
Figure 1. Elevation View of the Alamosa Canyon Bridge

The Alamosa Canyon Bridge has seven independent spans with a common pier between successive spans. An elevation view of the bridge is shown in Fig.1. Each span consists of a concrete deck supported by six W30x116 steel girders. The roadway in each span is approximately 7.3 m (24 ft) wide and 15.2 (50 ft) long. A concrete curb and guard rail are integrally attached to the deck. Plans for the bridge do not show shear studs on the top flanges of the girders. Inspection of the bridge showed that the upper flanges of the girders are imbedded in the concrete. Four sets of cross braces are equally spaced along the length of the span between adjacent girders. The cross braces are channel sections (C12x25). A cross section of the span at a location showing the interior cross braces is shown in Fig. 2. At the pier the girders rest on rollers as shown in Fig. 3. Also shown in Fig. 3 is the connection detail at the abutment where the beams are bolted to a half-roller to simulate a pinned connection. The bridge is aligned primarily in a north-south direction.

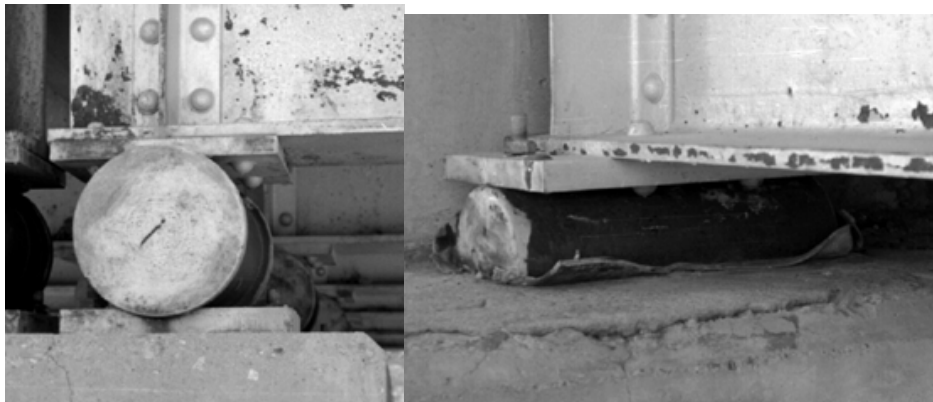
Pier

Abutment

Figure 3. Support details at the pier and abutment.
